**Attachment 4**  
**Woodridge Lake Sewer District**  
**Flow Isolation and CCTV Investigations 2011**

**Attachment 5**  
**Woodridge Lake Sewer District**  
**Building Inspections 2011**

**Attachment 6**  
**Woodridge Lake Sewer District**  
**Smoke Testing 2011**

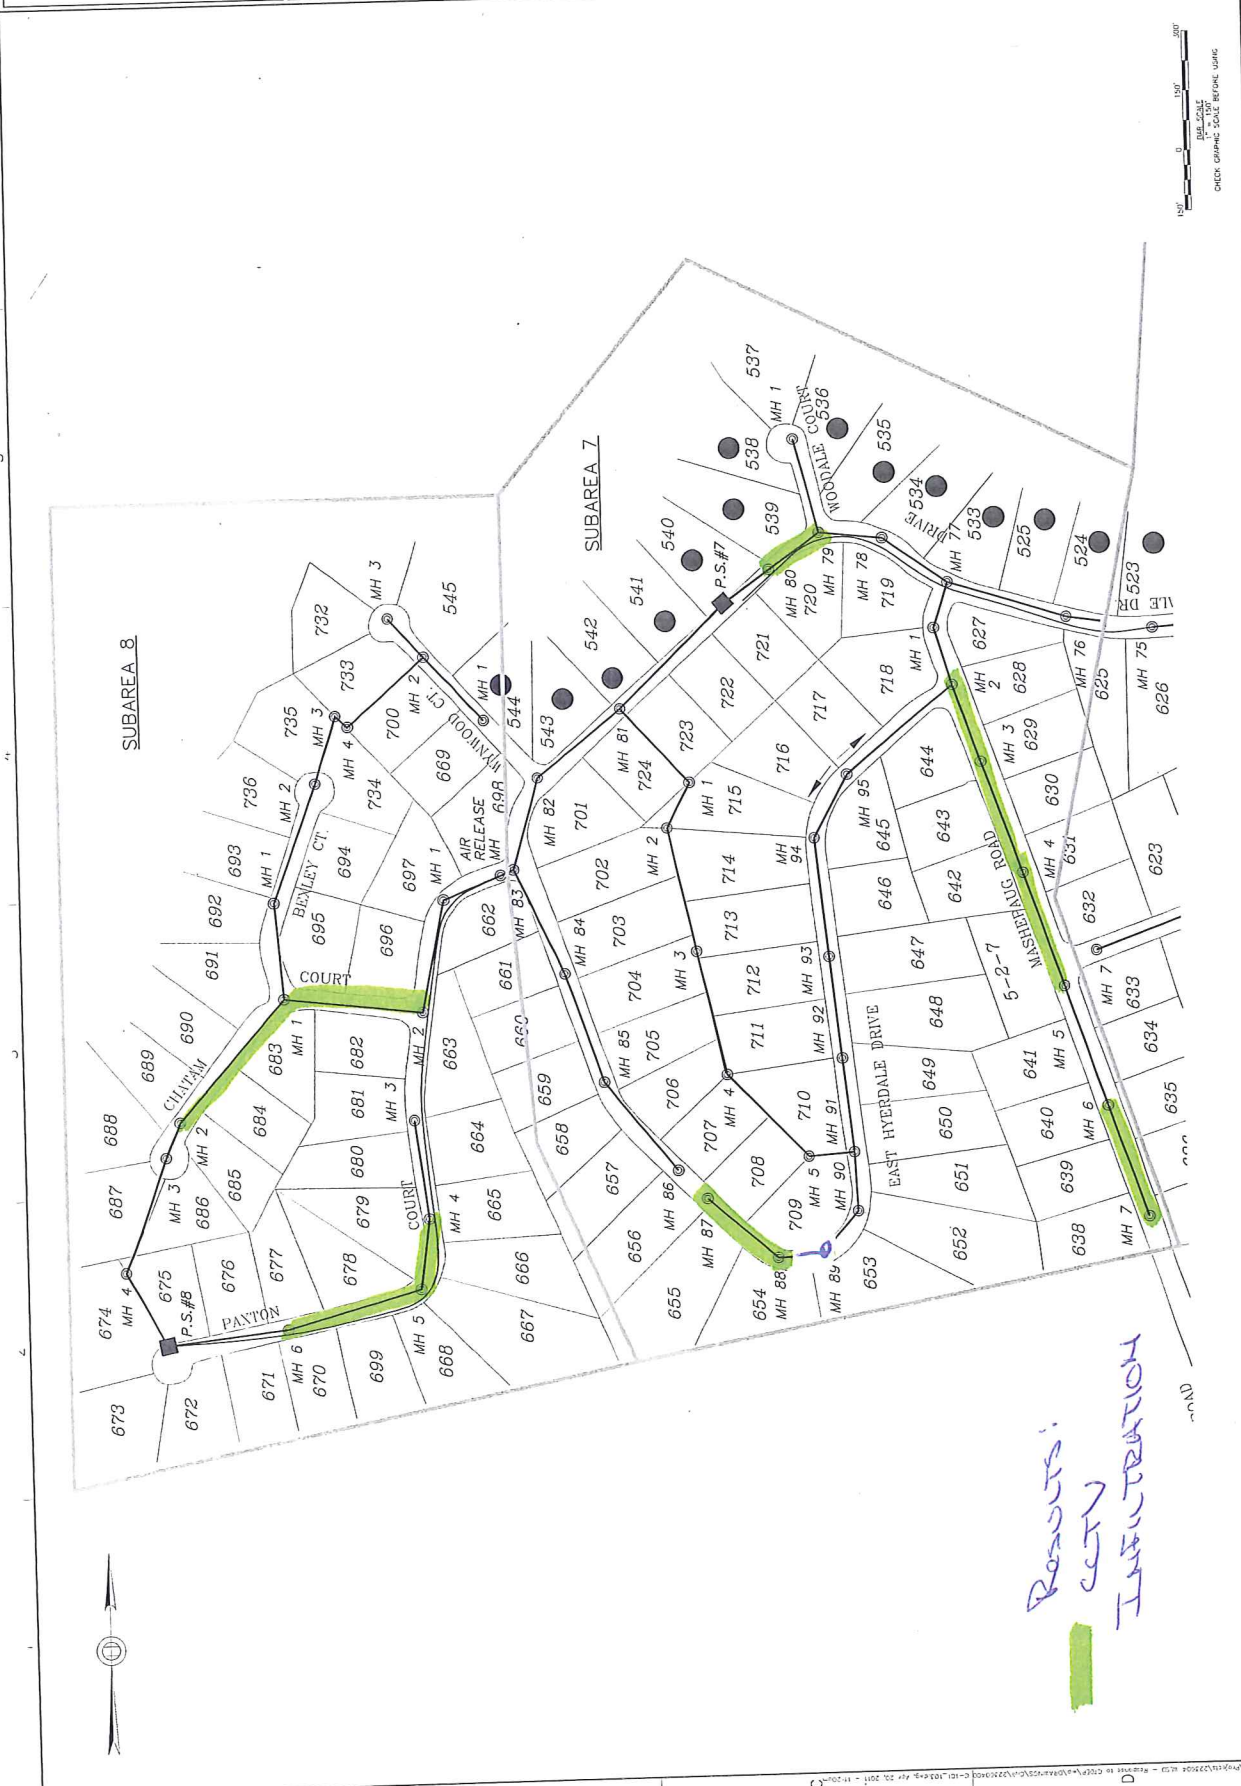
WOODARD & CURRAN COMMITMENT & INTEGRITY DRIVE RESULTS   www.woodardcurran.com	DATE: 04/23/2011 SCALE: AS SHOWN SHEET: 1 OF 2	WOODBRIDGE LAKE SEWER DISTRICT GOSHEN, CT.	C-101
	PROJECT: SUBAREA 7 AND 8

Results:  
 CTV  
 INFILTRATION

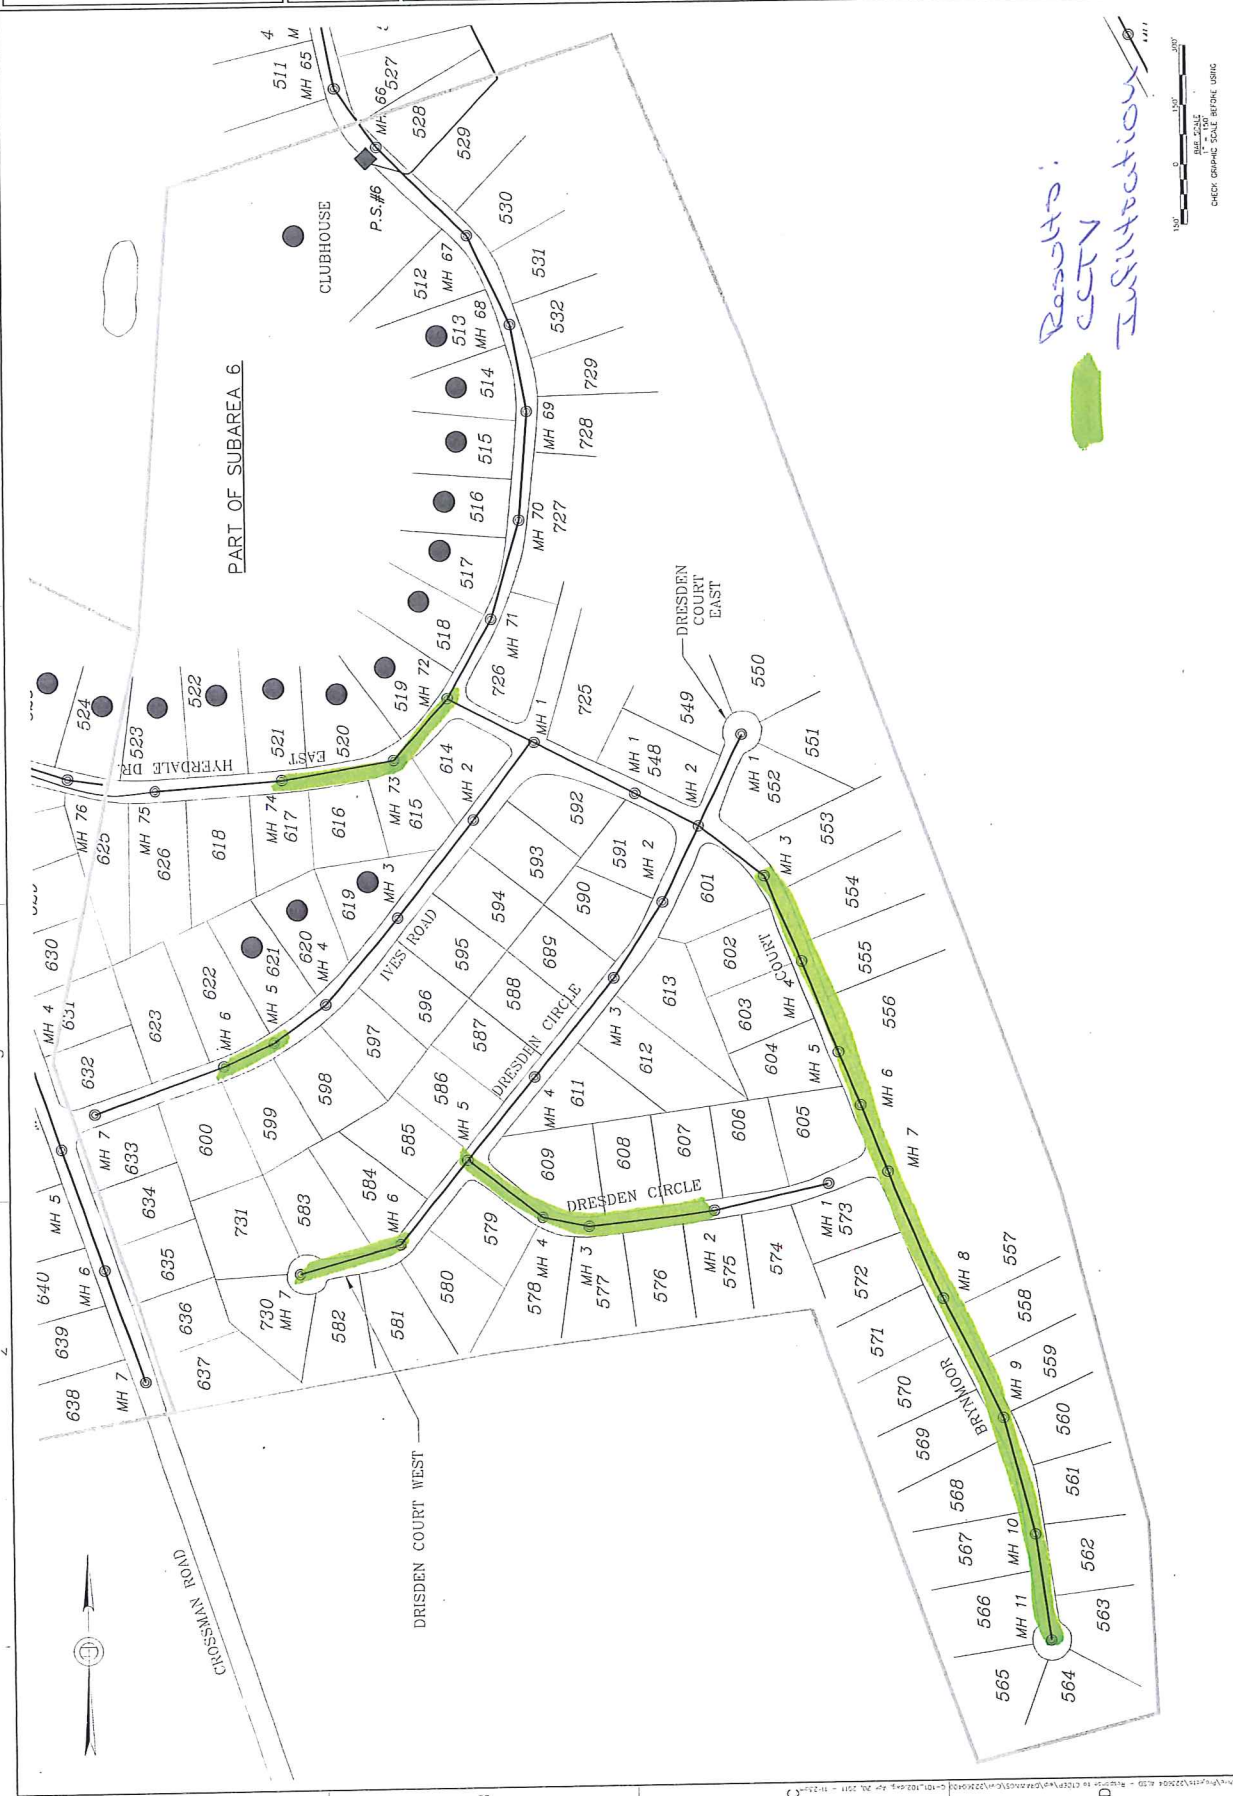
WOODBRIDGE LAKE SEWER DISTRICT  
 GOSHEN, CT  
 DATE: APRIL 2011  
 SCALE: AS SHOWN  
 SHEET: 01  
**C-102**

*Results:  
 CUT  
 Full Protection*
